# NASA Facts

## Proving the Space Transportation System The Orbital Flight Test Program

by Tony Reichhardt

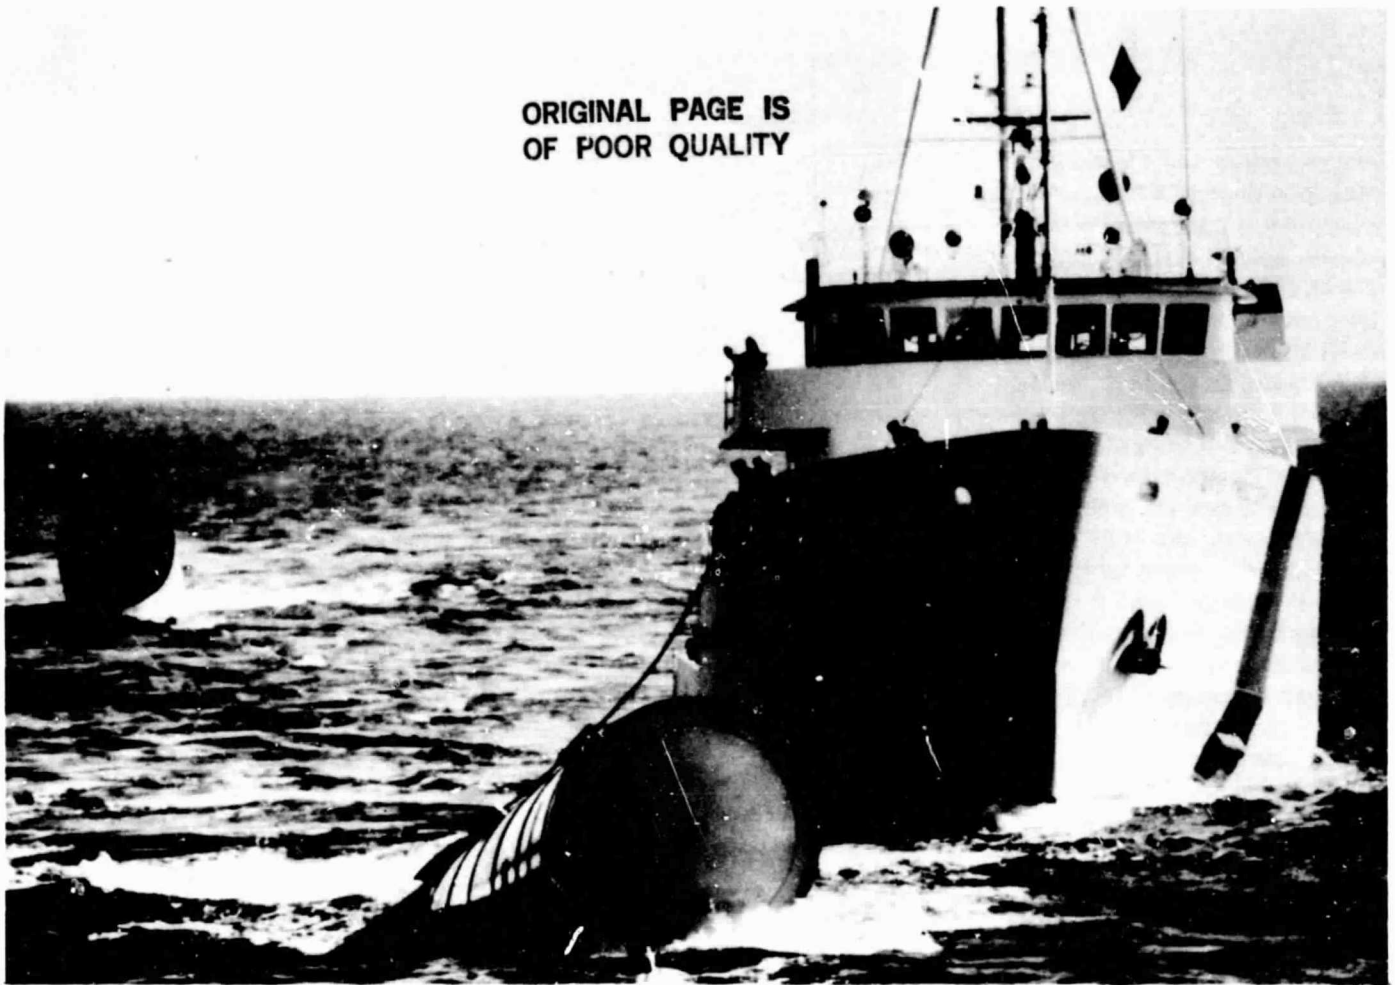
**Twin solid rockets separate from the External Tank, then parachute down to the Atlantic Ocean for recovery. Because there were problems with separation of the parachutes during the test flights, they were left attached to the rockets after water impact on STS-5.**

On the first and third flights, however, some parachutes sank before recovery. Then, on STS-4, the separation bolts fired prematurely due to strong vibrations, the parachutes detached from the rockets before water impact, and the rockets hit the water at too great a speed and sank. They were not recovered. As a result of these problems, the recovery hardware and

procedures were altered beginning with STS-5. Instead of separating automatically with explosives, the parachutes remained attached to the boosters through water impact, and were detached once the recovery team arrived. There were also sections of the boosters strengthened as a result of water impact damage seen on the test flights.

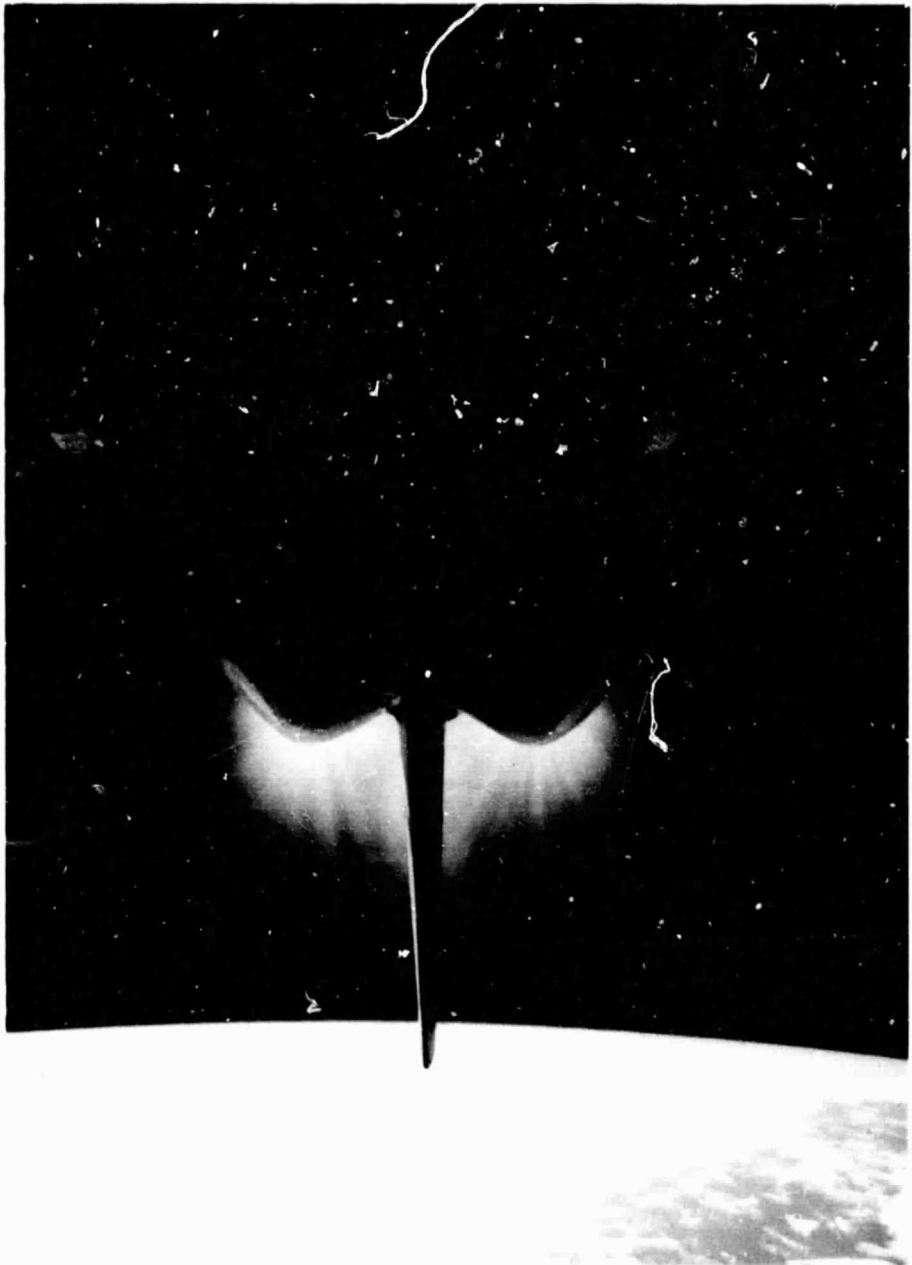
**STS-1 tested payload bay doors and deployment of radiator panels (left). Photo also shows blanketed "box" of Data Flight Instrumentation (DFI) in the rear of cargo bay, and missing white tiles on aft engine pod (upper right).**

The STS-1 crew ran an important series of payload bay door tests during *Columbia's* first few hours in space. The doors were first unlatched from the bulkheads and from each other. One at a time they were opened in the manual drive mode, while TV cameras and the crew recorded their motion. The movement of the doors was slightly more jerky and hesitant in space than in Earth-gravity simulations, but this was expected, and did not affect their successful opening and closing. The doors were closed and re-opened again one day into the STS-1 mission as a further test, then closed for good before re-entry. The crew verified normal alignment and latching of the doors as did the STS-2 crew during their door cycling

Door cycling was also tested after prolonged exposure to heat and cold. The doors are made of a graphite-epoxy composite material, while the Orbiter itself is made of aluminum. It was therefore important to understand how they would fit together after the aluminum expanded or contracted in the temperature extremes of space. At the beginning of STS-3 orbital operations the doors were opened as usual. The payload bay was then exposed to cold shadow for a period of 23 hours. When the port-side door was closed at the end of this "coldsoak" it failed to latch properly,

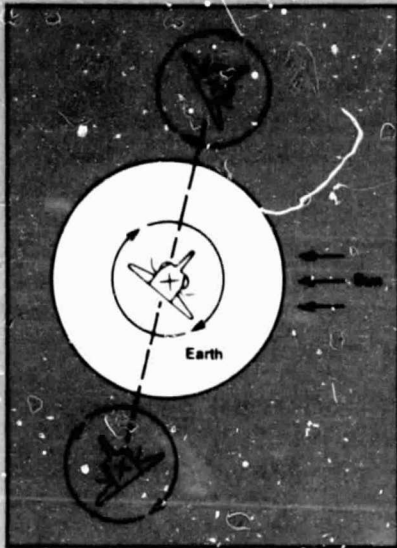
PASSIVE THERMAL CONTROL  
(Barbecue Mode)

Thermal testing of Orbiter was accomplished by holding different attitudes relative to the Sun for long periods.

The solution on both flights was the same, and has become standard procedure for closing the doors following a long cold exposure: the Orbiter holds a top-to-Sun position for 15 minutes to warm the cargo bay, then undergoes a short
